[Docket No. 2001-SW-39-AD; Amendment 39-12751; AD 2002-10-05]

Airworthiness Directives; MD Helicopters Inc. Model MD-900 Helicopters

2002-10-05 MD Helicopters, Inc.: Amendment 39-12751. Docket No. 2001-SW-39-AD. Supersedes AD 2001-07-09, Amendment 39-12175, Docket No. 2000-SW-15-AD.

Applicability: Model MD-900 helicopters, with main rotor upper hub (hub) assembly, part number (P/N) 900R2101006-105 or P/N 900R2101006-107, installed, certificated in any category.

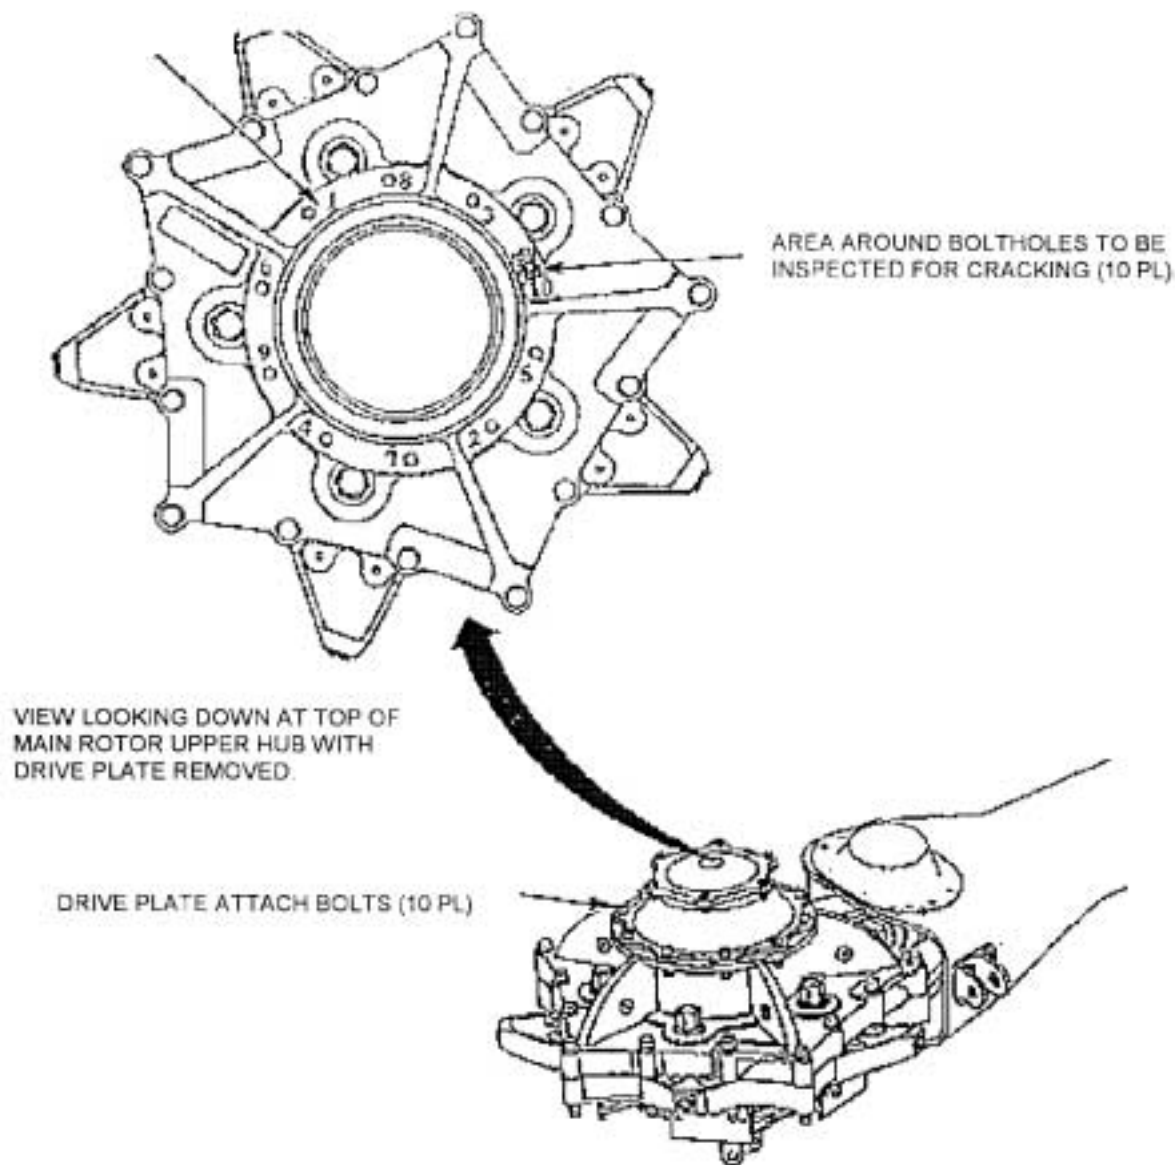
Figure 1. Main Rotor Upper Hub Assembly Inspection

(ii) Mark the main rotor hub holes to correspond with the drive plate hole numbers (see Figure 1 of this AD).

(v) Using paint stripper (Consumable Item List C313 or equivalent) and cleaning solvent (C420 or equivalent), remove the paint from the upper mating surface of the hub assembly to enable an accurate visual inspection of each drive plate attachment bolt hole (bolt hole) area for cracking (Figure 1). Ensure the paint stripper and solvent DO NOT contaminate the upper bearing and upper grease seal areas.

(vi) Using a 10x or higher magnifying glass and light, inspect the mating surface area and the area around and inside the 10 bolt holes of the hub assembly for a crack. If a crack is found, before further flight, replace the hub assembly with an airworthy hub assembly.

(viii) Reinstall the main rotor drive plate using 10 new sets of replacement attachment hardware. Torque the nuts to 160 inch pounds above locknut locking/run-on torque in the sequence shown (Figure 1). Record in the rotorcraft logbook, or equivalent record, the locknut locking/run-on torque for each nut.

1. MAIN ROTOR DRIVE PLATE ATTACHMENT
HARDWARE TORQUE SEQUENCE.
2. NUMBERING MAY START AT ANY HOLE.
3. TORQUE NUTS TO 1/2 TOTAL TORQUE,
THEN FULL TORQUE.
